CONNECTICUT WESTERN COASTAL AREA
GREENWICH, CONNECTICUT

PUTNAM RESERVOIR DAM
CT 00041

PHASE I INSPECTION REPORT
NATIONAL DAM INSPECTION PROGRAM

AUGUST 1978

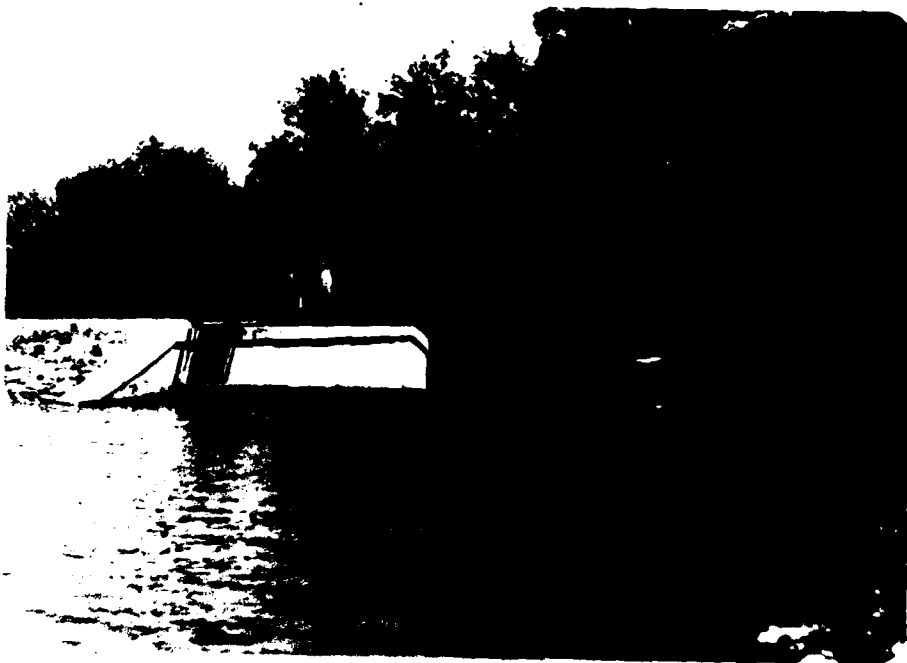
PHOTO #3: Upstream Face of Spillway.

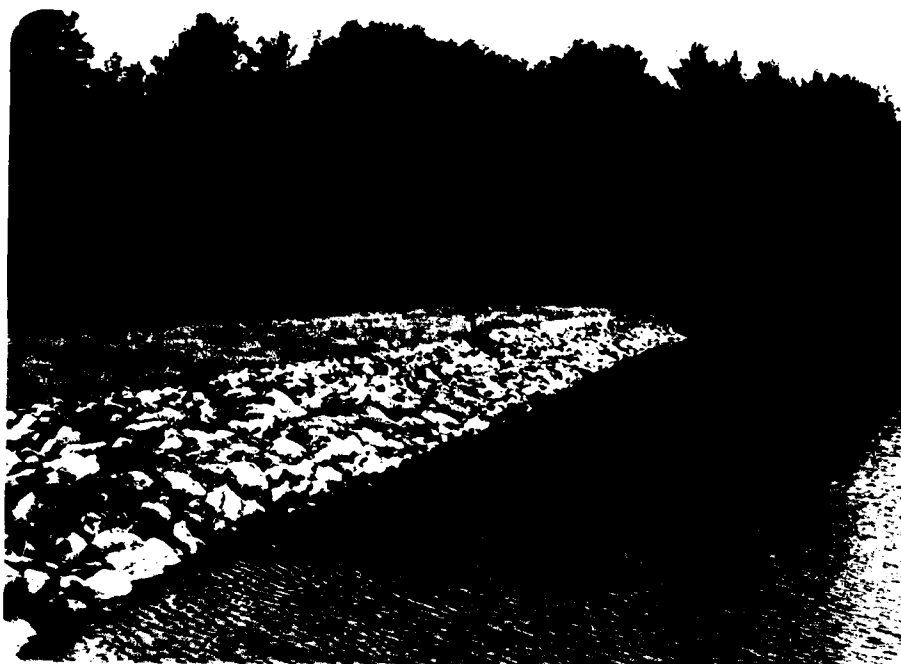
PHOTO #7: Riprap on Upstream Face of Dam, looking West from Intake Structure.

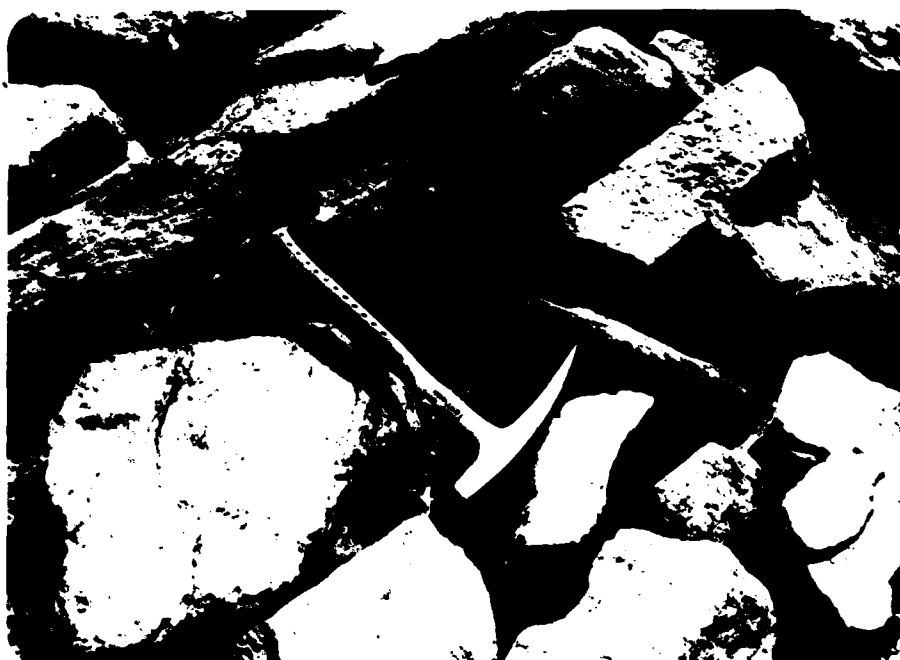
1) Upstream Slope - At the time of the visual inspection of the dam, the reservoir level was approximately 1 foot below the spillway crest, and thus only the upper few feet of slope could be observed. The riprap protection inspected was generally in good shape with an occasional small window exposed through the riprap. Near Station 7+00 on the left side of the dam, there is some erosion and settling of the riprap.

PHOTO #8: Riprap detail at Sta. 7+00. Note extent of coverage.
